FINAL REPORT ON ALL SHUTTLE CENTAUR ENGINE AND NOZZLE SUPPORT PLUG VIBRATION TESTING

CONTRACT NAS3-23791

Prepared by
United Technologies Corporation
Pratt & Whitney
Government Products Division
P.O. Box 109600, West Palm Beach, Florida 33410-9600

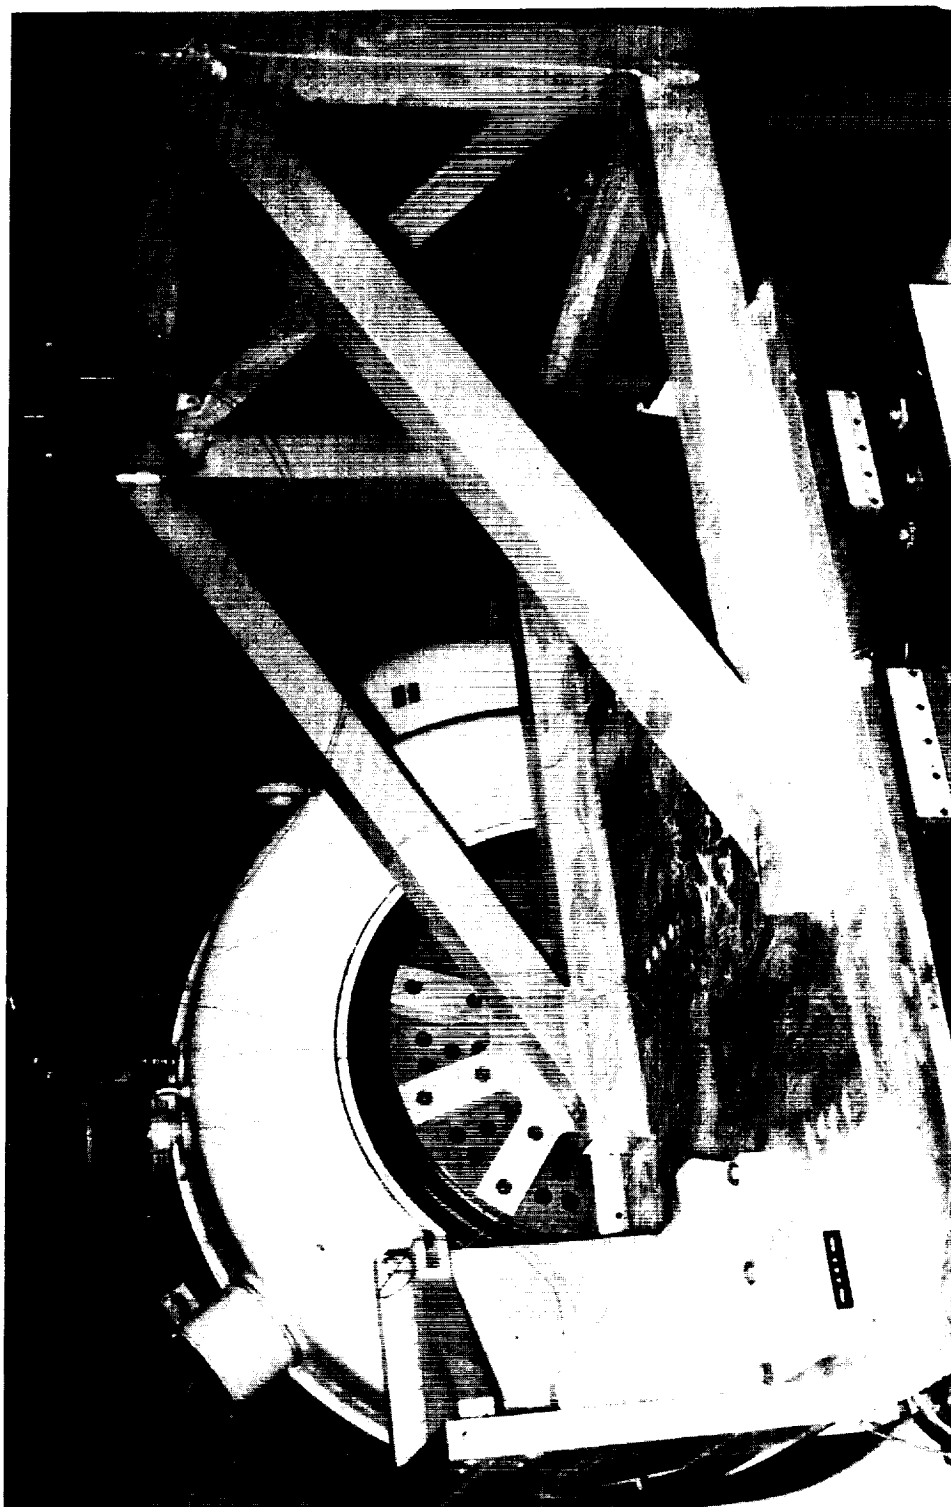
Figure 1. Engine Test Fixture

A fixture was built to hold the engine in a manner similar to that in the STS/Centaur configuration shown in Figure 1.
